Blue Springs Lake

Operation and Maintenance Manual

Construction Foundation Report

Volume One

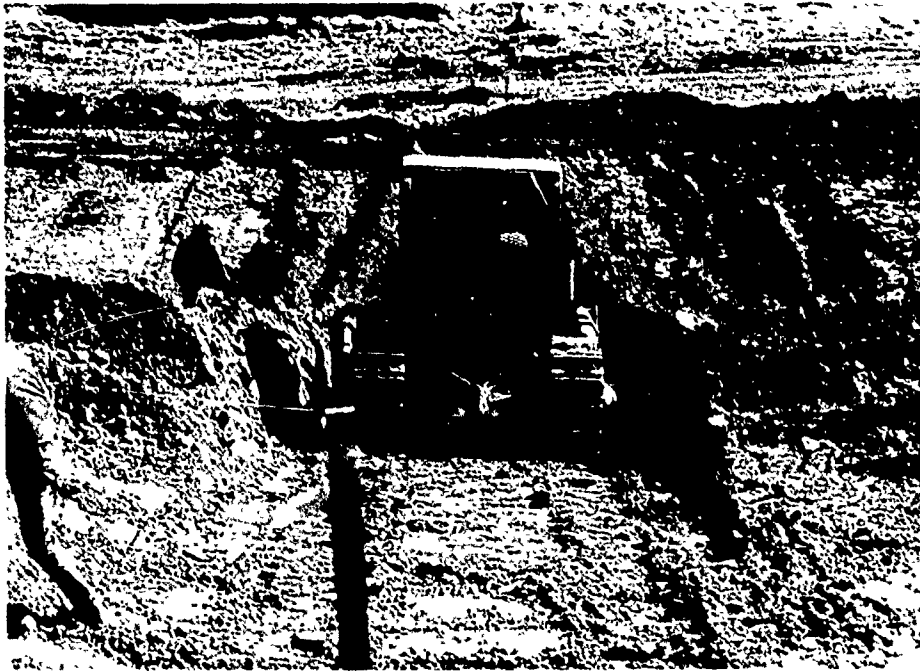
3. Blue Springs Lake, 14 October 1982, Neg. No. 37.
Left abutment. Sta. 99+00. Initial cutoff trench
excavation, looking west.

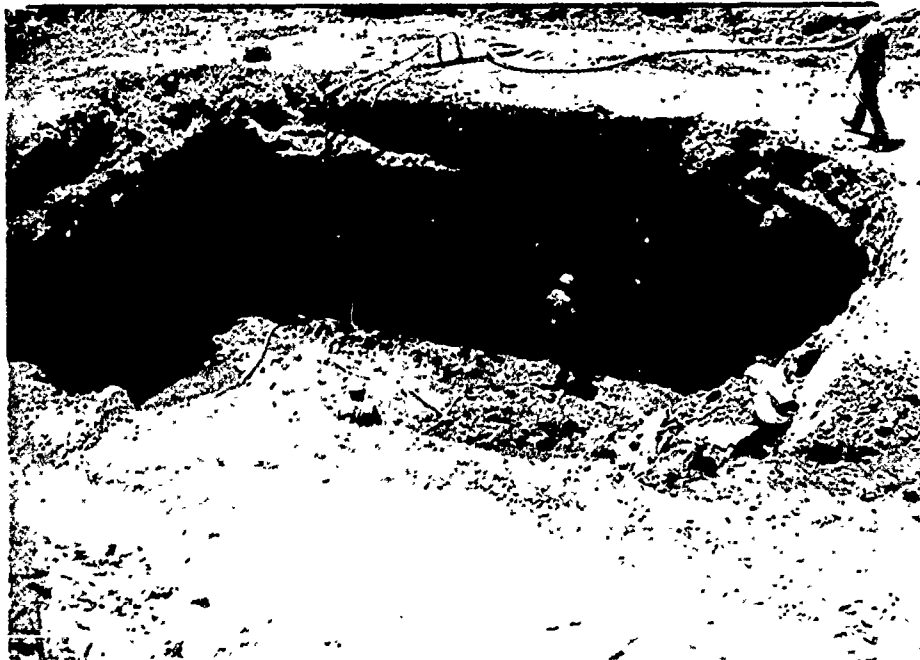
18. Blue Springs Lake, 5 July 1983, Neg. No. 131.
Tower excavation.

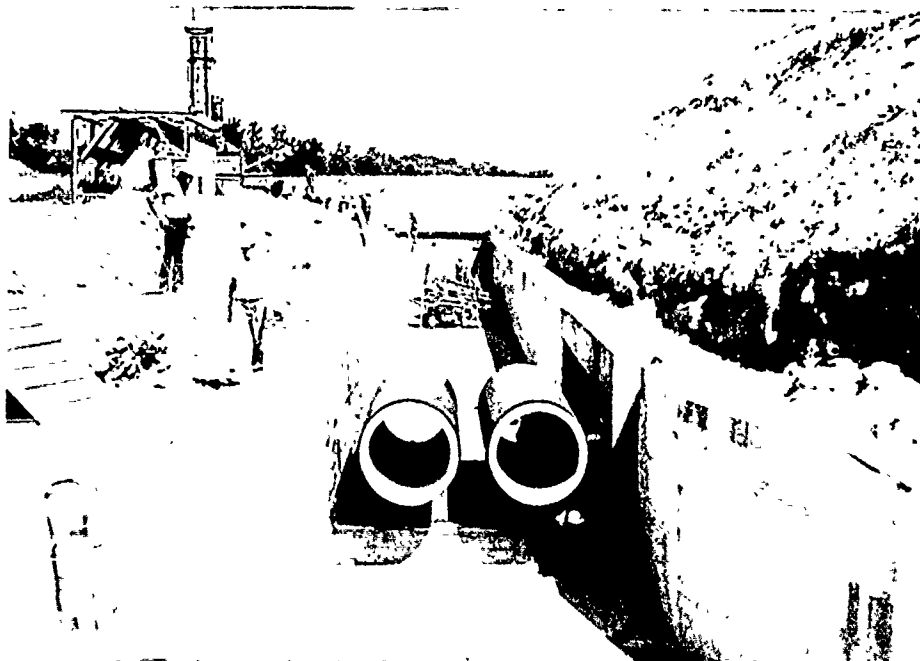
27. Blue Springs Lake, 1 August 1983, Neg. No. 157.
Outlet works excavation. Sewer pipe installation.
Looking downstream from station 47+70.

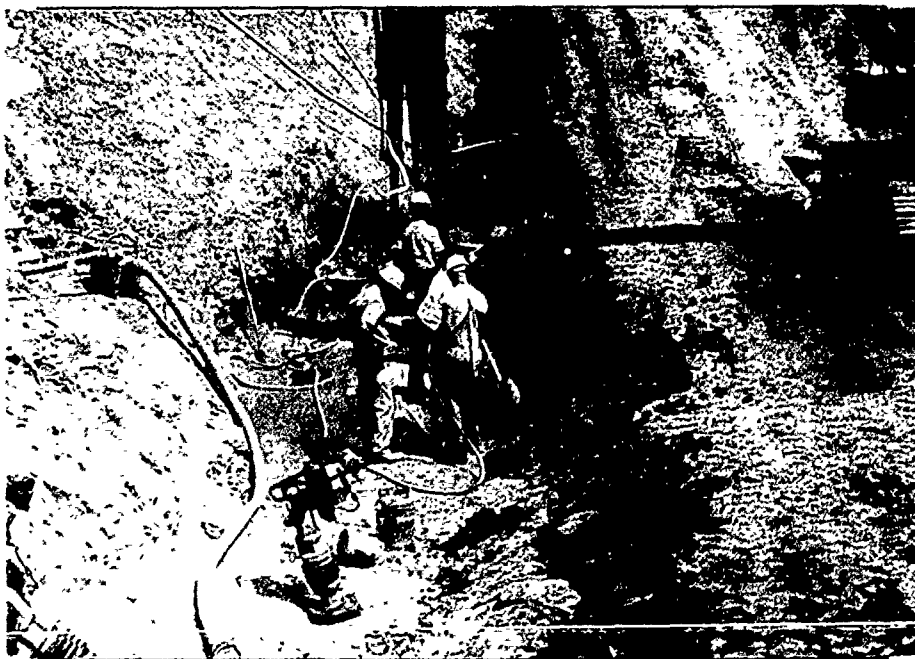
34. Blue Springs Lake, 13 August 1983, Neg. No. 186.
Left abutment cutoff trench. Foundation clean up
at station 97+10, prior to start of pervious placement.

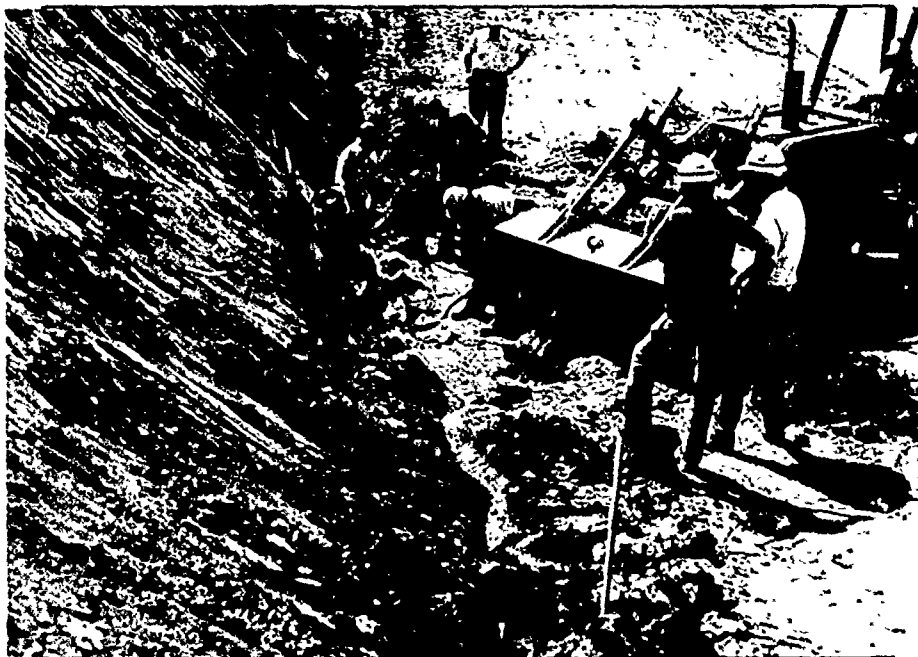
35. Blue Springs Lake, 15 August 1983, Neg. No. 189.
Left abutment cutoff trench. Placement of upstream
sand drain at station 96+90.

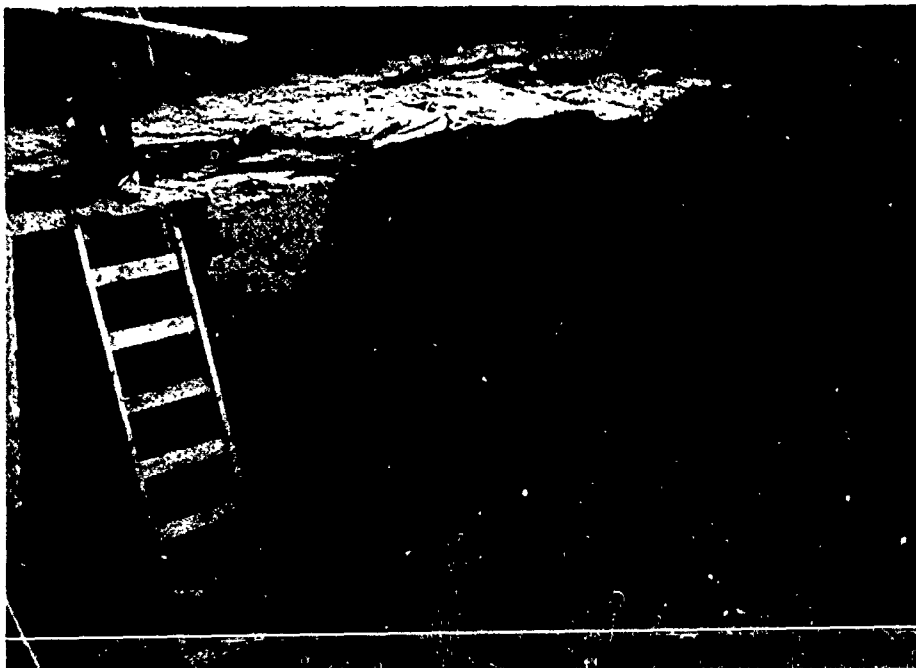
52. Blue Springs Lake, 23 June 1984, Neg. No. 285.
Sewer/Outlet works excavation. Right side wall from
station 96+85 to station 97+09, looking upstream.

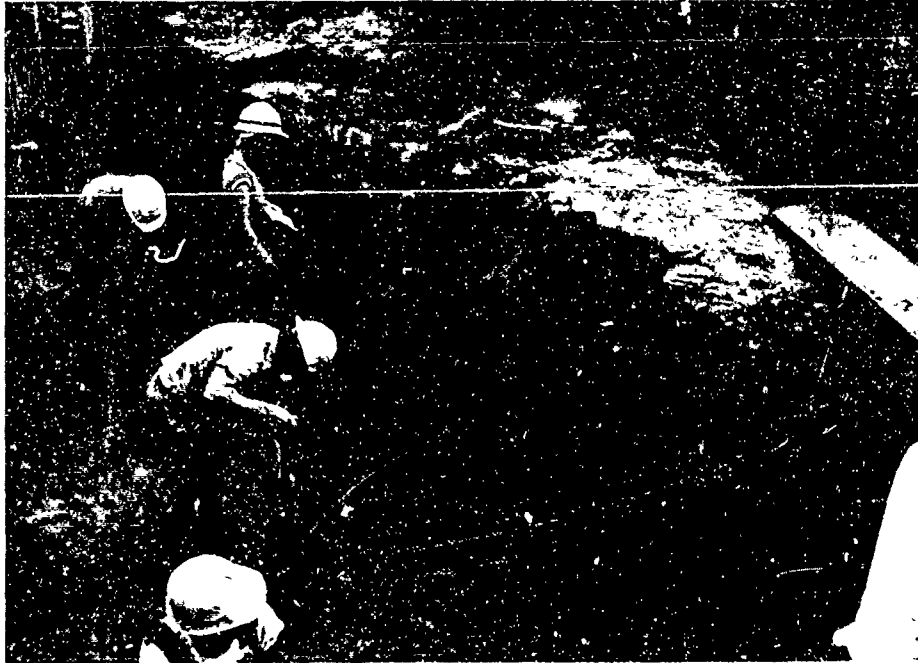
55. Blue Springs Lake, 3 July 1984, Neg. No. 295.
Sewer/Outlet works excavation. Right wall from
station 96+70 to station 96+55, looking downstream.

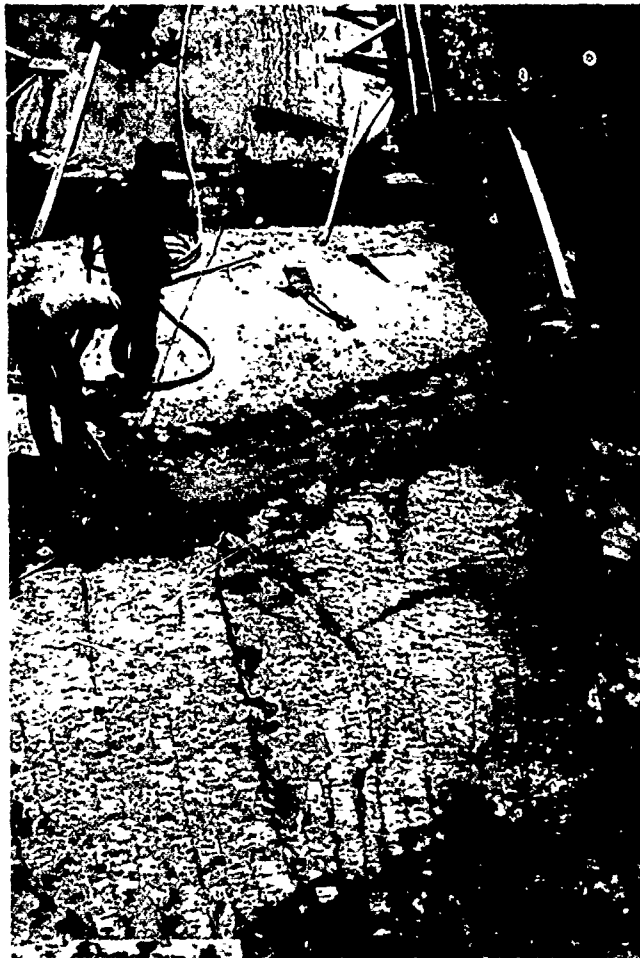
59. Blue Springs Lake,
30 July 1984,
Neg. No. 308.
Stilling basin, east
side from station
53+53 to station 53+00,
looking upstream.

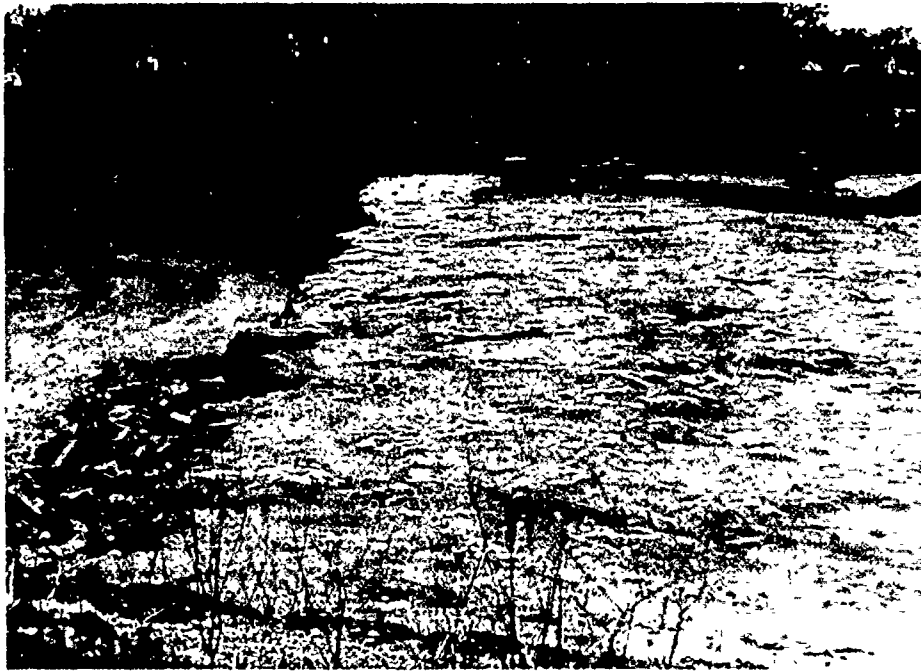
69. Blue Springs Lake, 24 April 1985, Neg. No. 408.
Top of Bethany Falls Limestone in spillway. From
dam center line station 103+00, looking west.

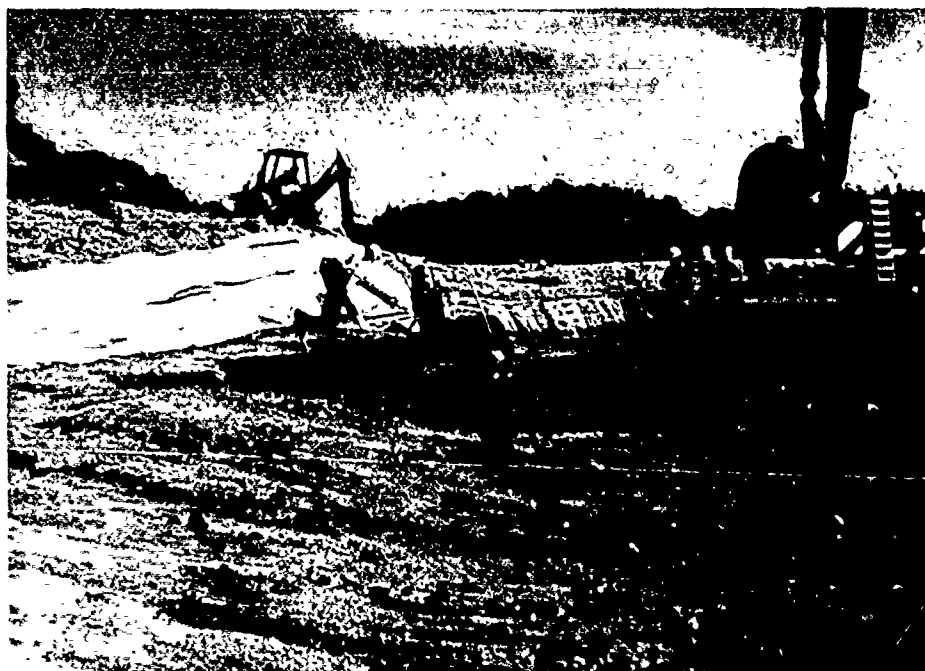
71. Blue Springs Lake, 3 May 1985, Neg. No. 420.
Left abutment. Jack Hammers being used to trim
Pleasanton "B" Sandstone to proper slope. Station
98+00 looking downstream.

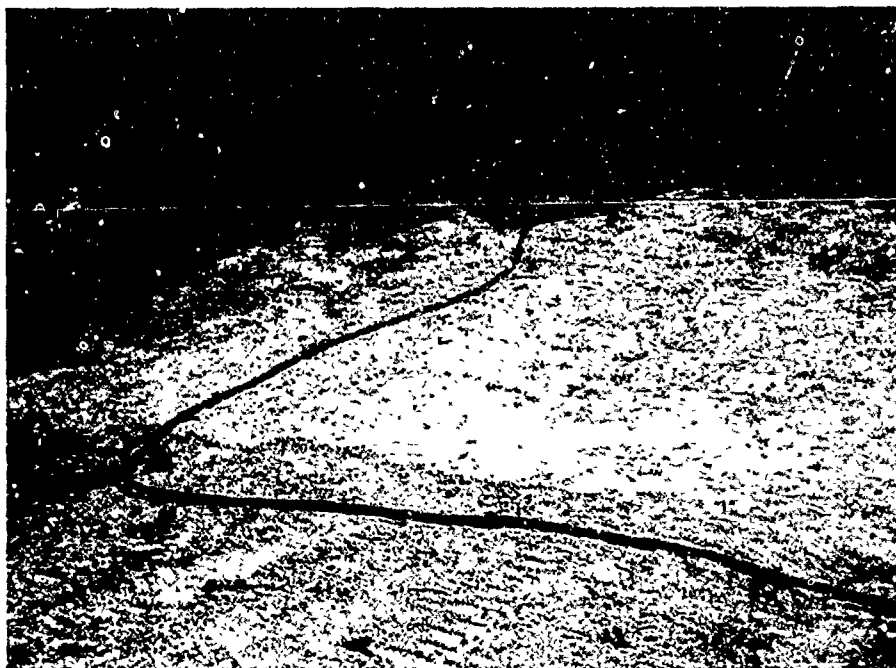
89. Blue Springs Lake, 24 July 1985, Neg. No. 498.
Shale floor in right abutment cutoff trench.
Beginning in weathered Pleasanton "C" Zone at
station 76+30.

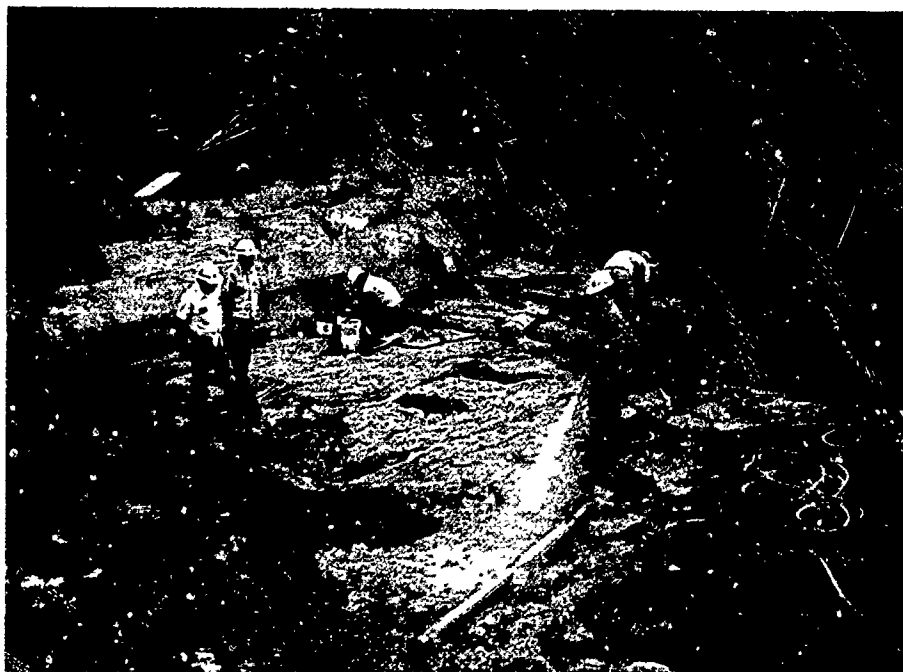
92. Blue Springs Lake, 29 July 1985, Neg. No. 502.
Pits jackhammered into Pleasanton "C" Shale
intercepting joints in cutoff trench floor, from
station 76+00 to station 76+30. Pits were filled
with 1.0 ft. of sand and covered with impervious
material.

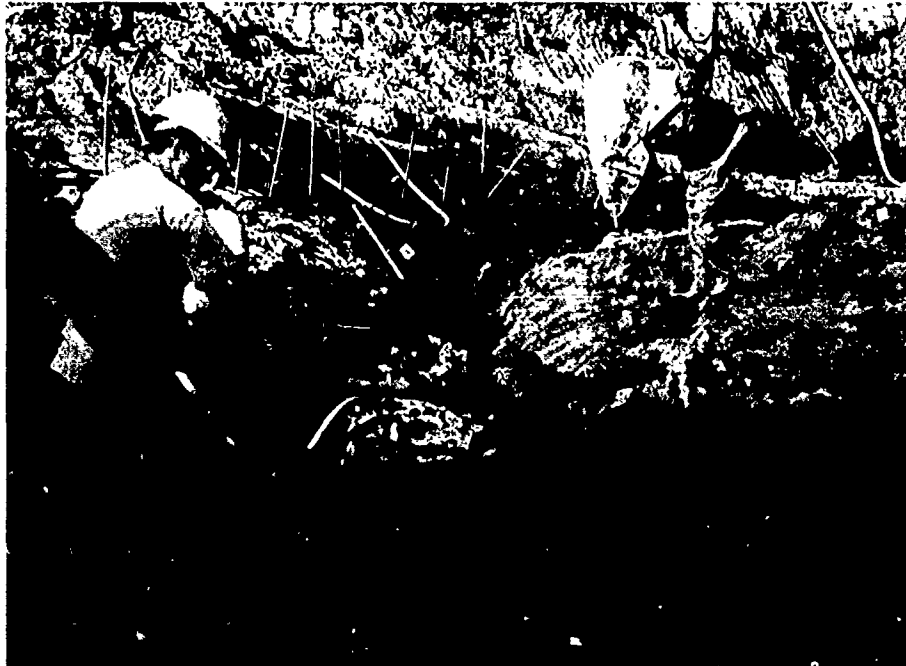
97. Blue Springs Lake, 12 August 1985, Neg. No. 536.
Right abutment upstream sand drain at station 76+30.

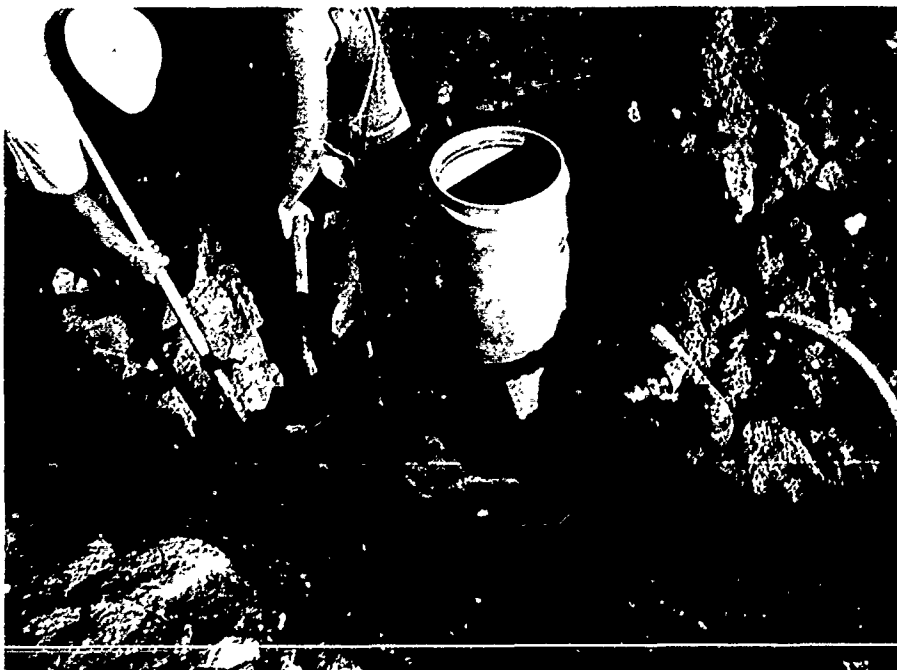
98. Blue Springs Lake, 12 August 1985, Neg. No. 538.
Perforated PVC pipe placed in upstream sand drain
at station 76+60.

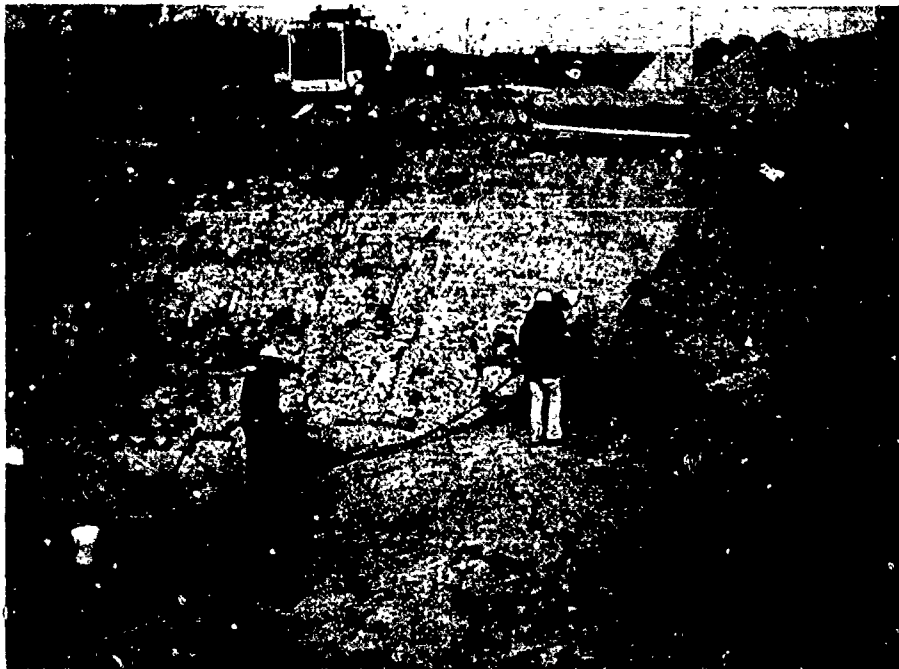
103. Blue Springs Lake, 30 October 1985, Neg. No. 564.
Right abutment cutoff trench. Downstream wall from
station 75+70 to station 76+00. From station 75+75,
50 feet upstream, looking north.

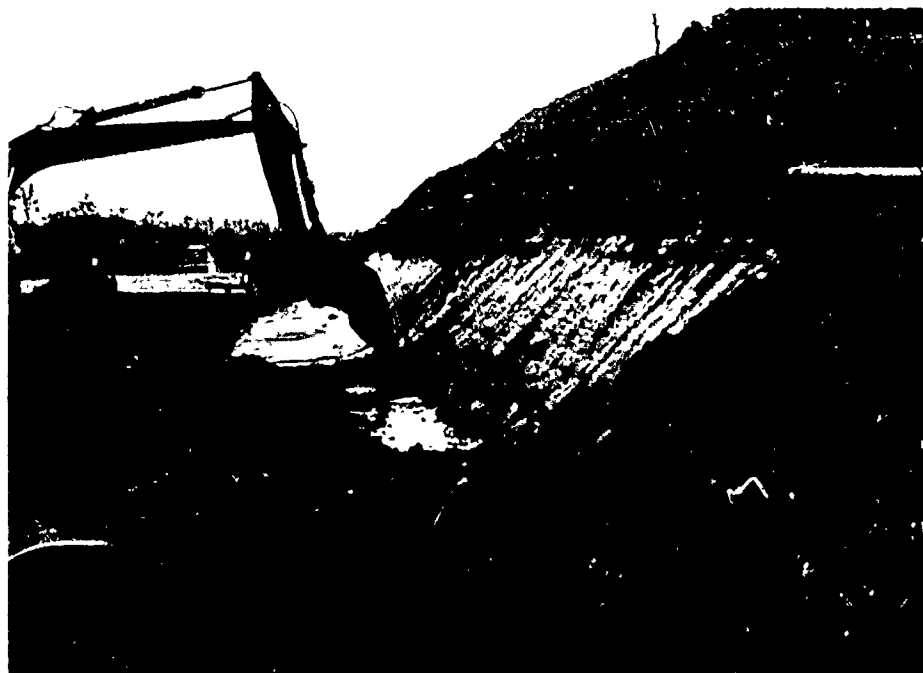
109. Blue Springs Lake, 17 April 1986, Neg. No. 604.
Right abutment. From station 47+90 on center
line of conduit, looking downstream. Top of
cleaned slope is at station 74+60.

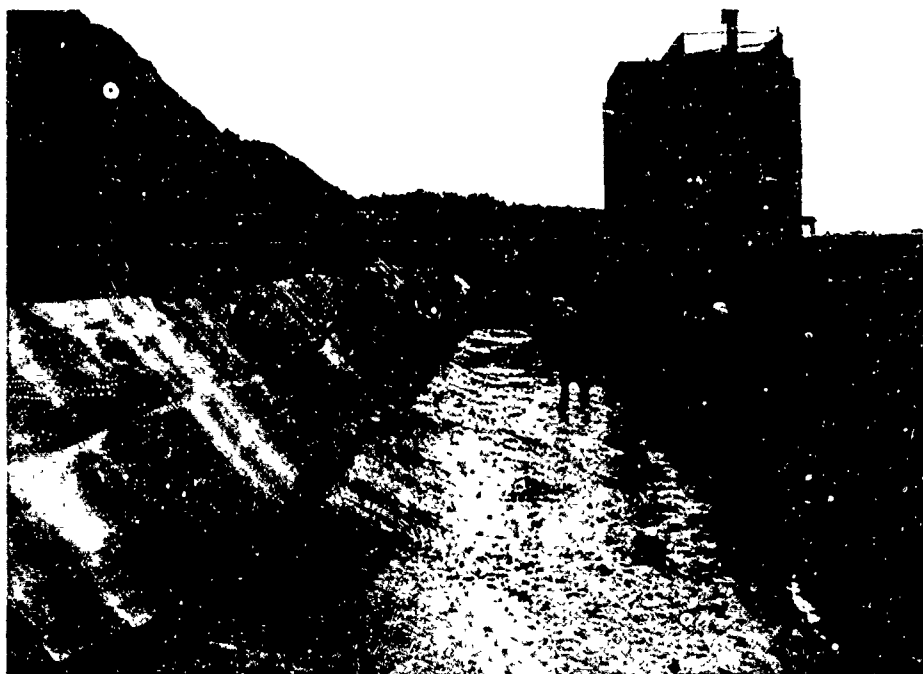
| <u>PHOTO NO.</u> | <u>SUBJECT</u> | <u>NEGATIVE NO.</u> |
|---|---|---|
| 111 | 17 Apr 86, right abutment, see photo No. 110 for details. | #609 |

111. Blue Springs Lake, 17 April 1986, Neg. No. 609.
Right abutment. See Photo No. 110 for details.

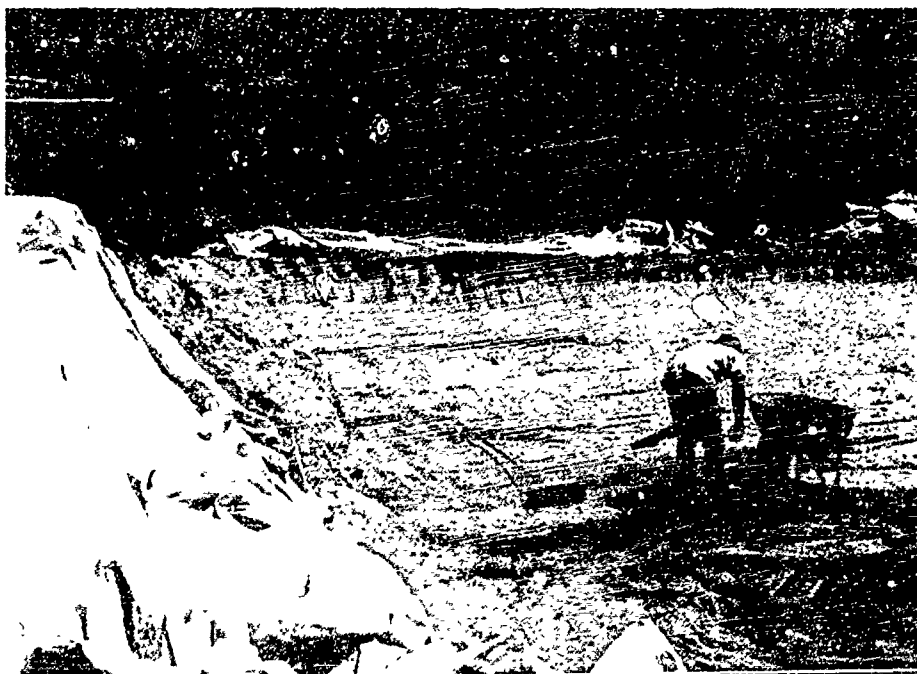
112. Blue Springs Lake, 26 April 1986, Neg. No. 613.
Right abutment. Cutoff trench from station 75+60
to station 75+48.5. From 25 feet downstream of
station 76+10, looking east, viewing downstream section.

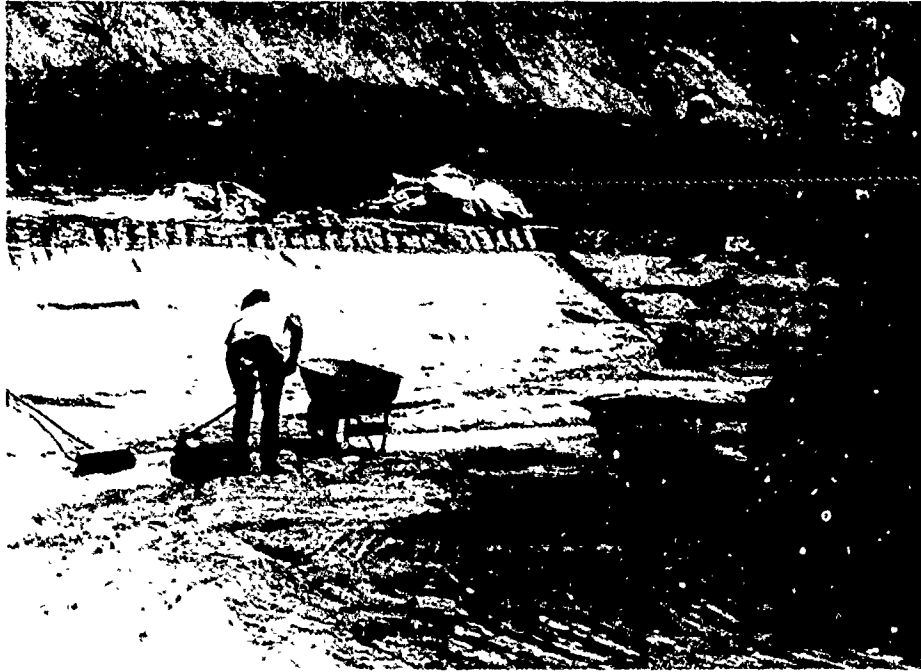
113. Blue Springs Lake, 26 April 1986, Neg. No. 614.
Right abutment. View of cutoff trench from station
75+60 to station 75+48.5. From 25 feet downstream
of station 76+10, looking east, viewing upstream section.

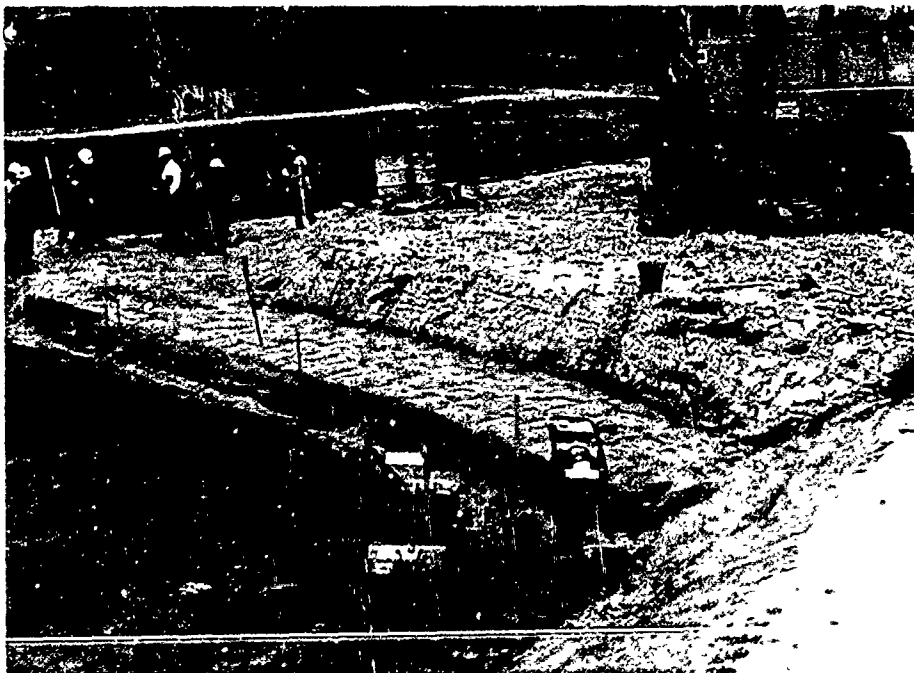
114. Blue Springs Lake, 30 April 1986, Neg. No. 617.
Right abutment. Cutoff trench, from 25 feet
upstream at station 75+40, looking northwest.

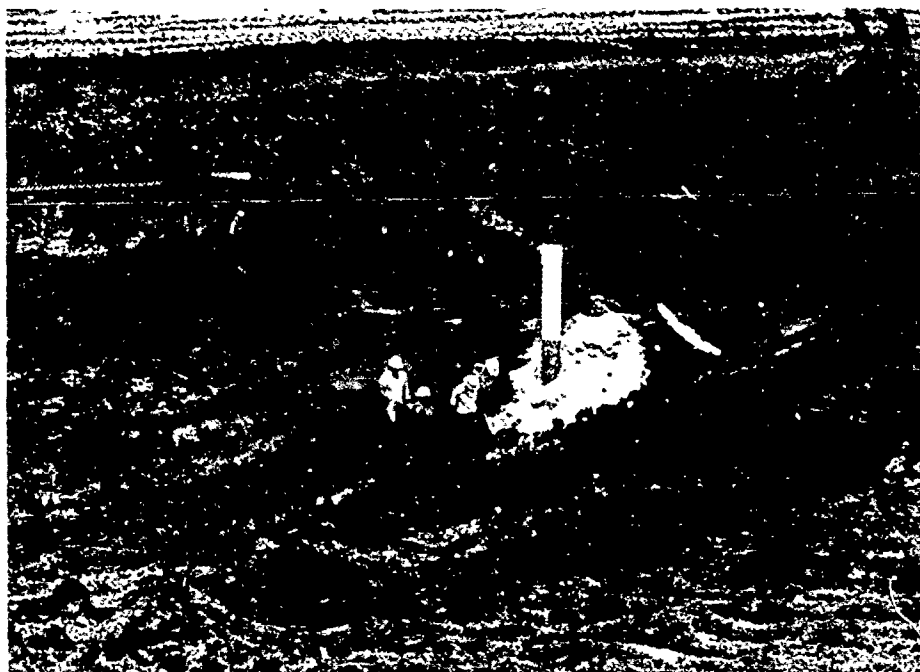
115. Blue Springs Lake, 6 May 1986, Neg. No. 621.
Sump placed at 19.6 feet upstream of station
77+18 at end of upstream sand drain.

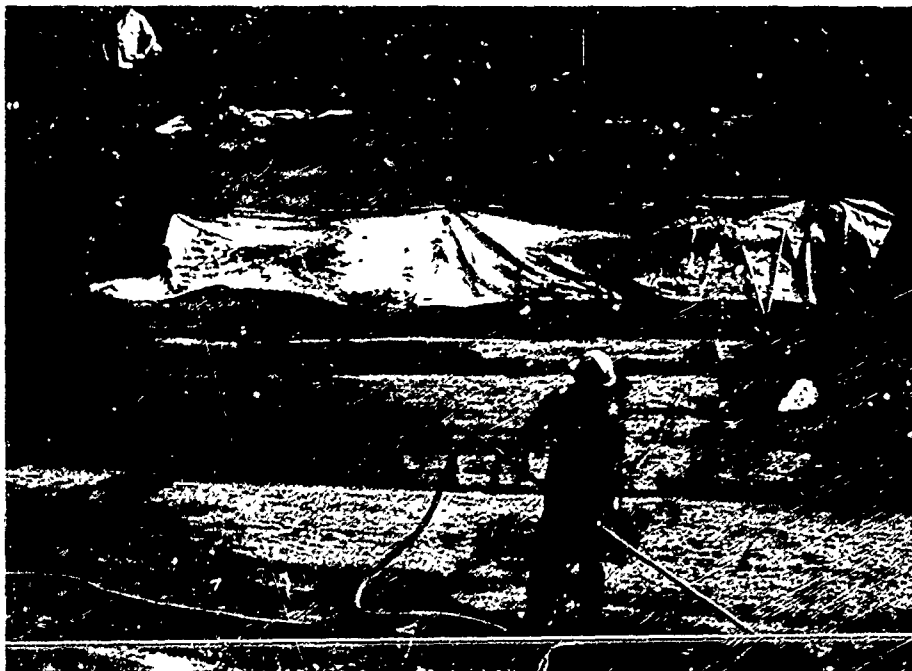
118. Blue Springs Lake, 28 June 1986, Neg. No. 659.
Right abutment, cutoff trench. View of downstream
wall from center line at station 74+70, looking
northeast.

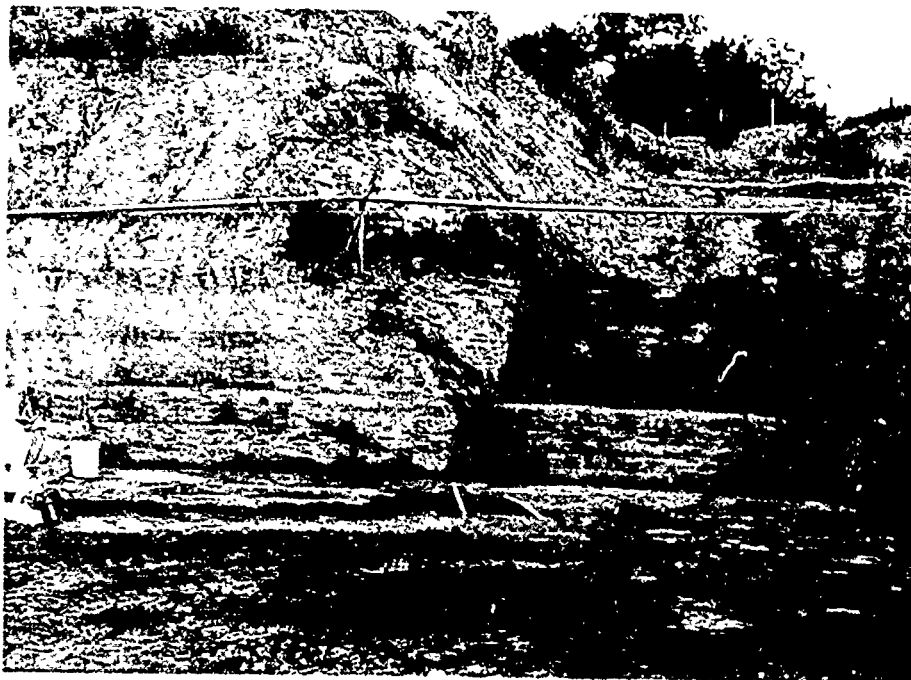
121. Blue Springs Lake, 24 July 1986, Neg. No. 671.
Right abutment, cutoff trench. Downstream section,
from center line of dam at station 75+00 looking
east. Lower bench El. 795, from station 74+30 to
station 74+17.

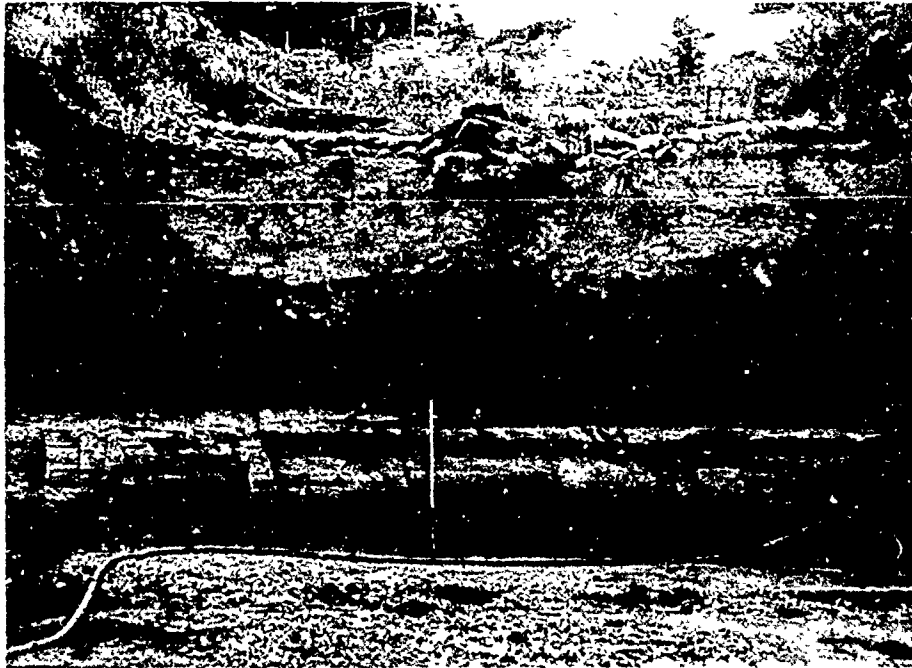
123. Blue Springs Lake, 13 August 1986, Neg. No. 677.
Right abutment, cutoff trench. View of center
section from station 74+17 to station 74+07 and
from El. 799.3 to El. 807.0. From center line
of dam at station 74+70, looking east.

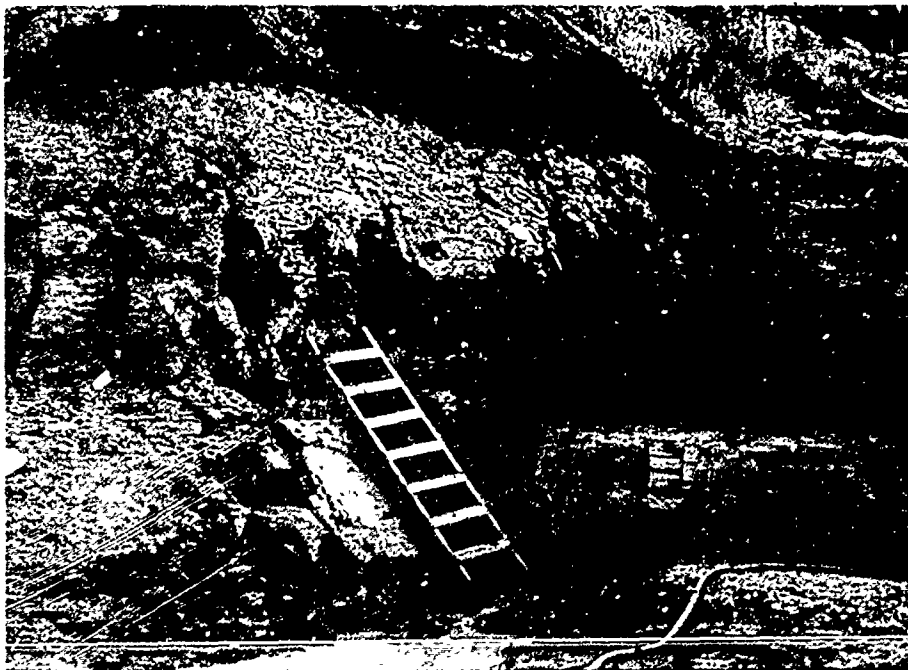
| <u>PHOTO NO.</u> | <u>SUBJECT</u> | <u>NEGATIVE NO.</u> |
|---|---|---|
| 124 | 13 Aug 86, right abutment, cutoff trench, downstream wall. Details as in photo No. 123. | #678 |

124. Blue Springs Lake, 13 August 1986, Neg. No. 678.
Right abutment, cutoff trench, downstream wall.
Details as in Photo No. 123.

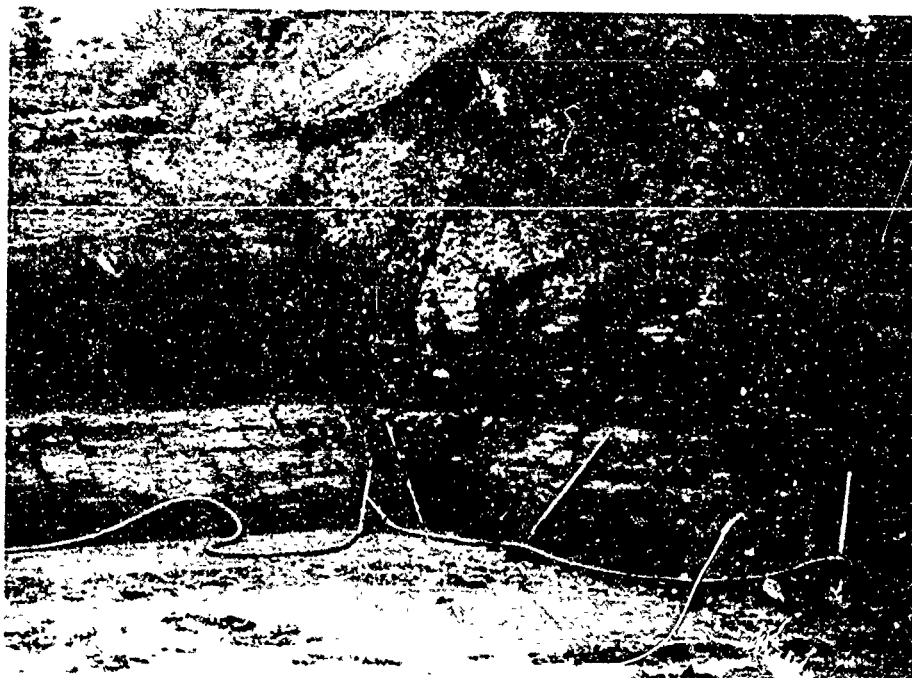
| <u>PHOTO NO.</u> | <u>SUBJECT</u> | <u>NEGATIVE NO.</u> |
|---|---|---|
| 125 | 13 Aug 86, right abutment, cutoff trench, upstream wall. Details as in photo No. 123. | #676 |

125. Blue Springs Lake, 13 August 1986, Neg. No. 676.
Right abutment, cutoff trench, upstream wall.
Details as in Photo No. 123.

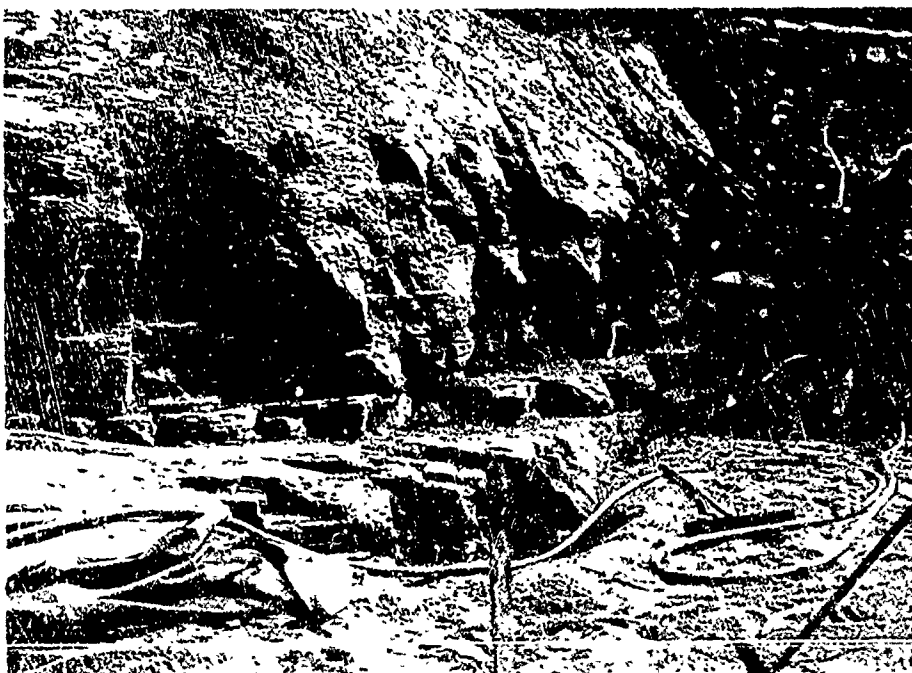
127. Blue Springs Lake, 19 August 1986, Neg. No. 680.
 Right abutment, cutoff trench at station 74+15.
 View of downstream wall after open fractures and
 joints were dry packed. The head of rock-hammer is
 at El. 802.5 at station 74+20.

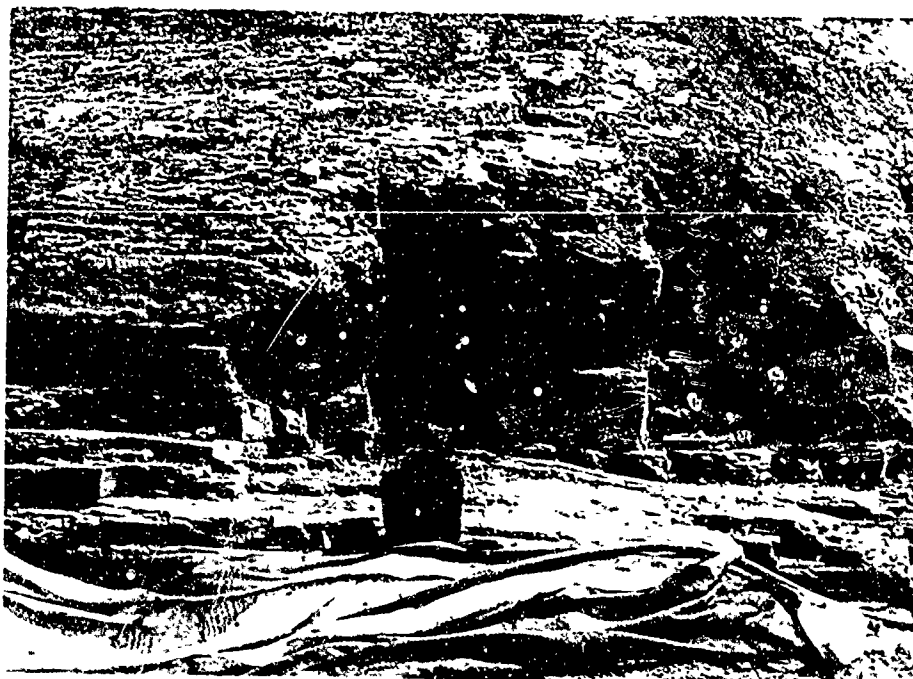
128. Blue Springs Lake, 19 August 1986, Neg. No. 681.
 Right abutment, cutoff trench. View of downstream
 wall from station 74+30 to station 74+10. The head
 of rock-hammer is at El. 802.5 from station 74+50
 and 20 feet downstream, looking east.

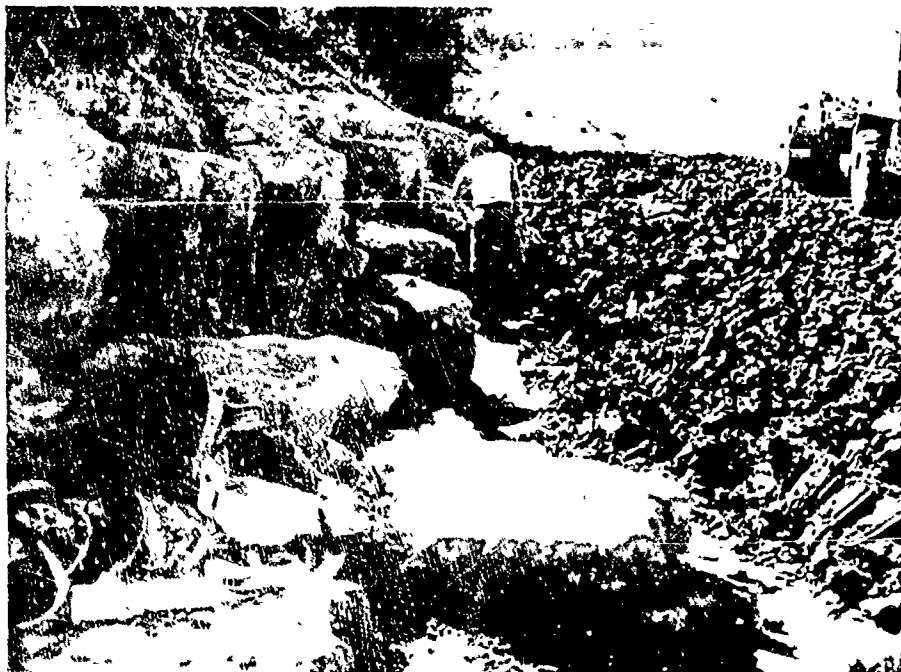
132. Blue Springs Lake, 5 August 1987, Neg. No. 692.
 Right abutment at station 74+00 looking downstream.
 Note Sniabar Limestone.

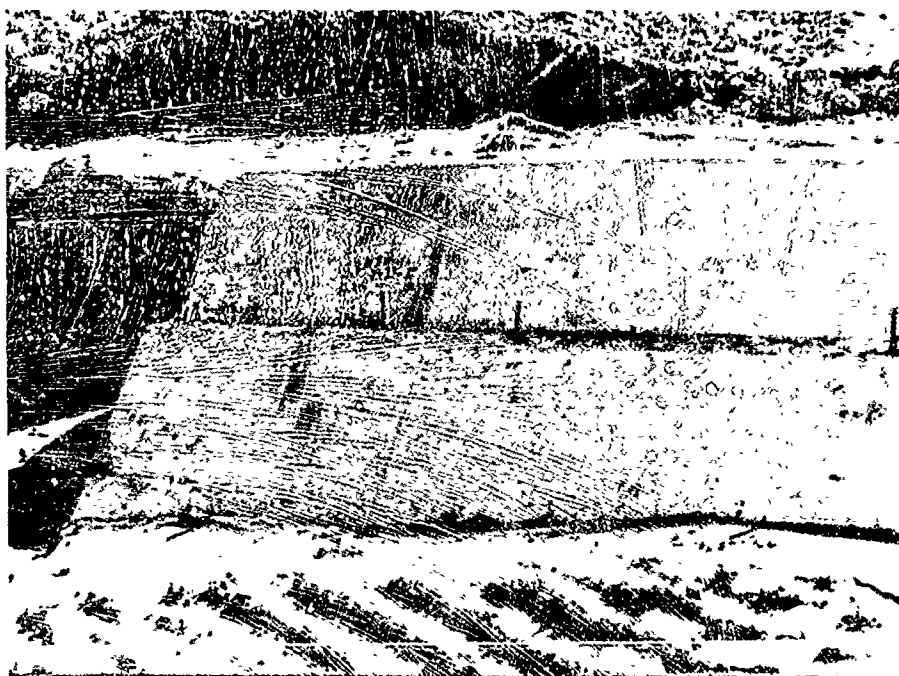
133. Blue Springs Lake, 5 August 1987, Neg. No. 693.
Right abutment. From station 73+90 looking
upstream. Note Sniabar Limestone.
